BUILDING STONES OF OLD AMSTERDAM

By Scott Engering *geologist and building stone consultant – contributing European editor*

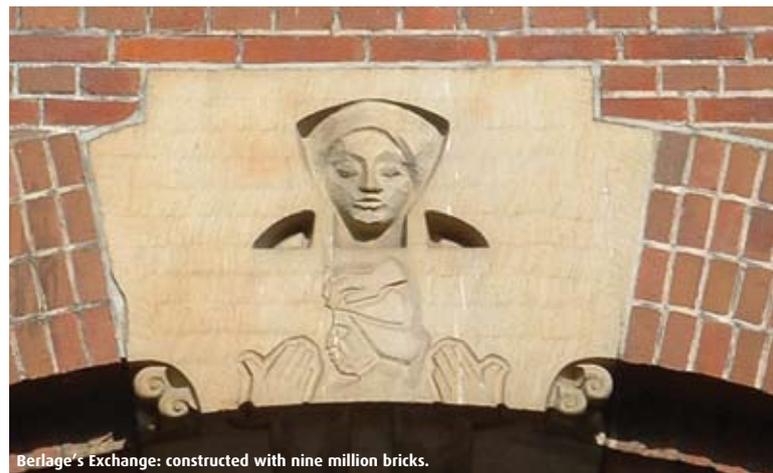
Berlage's Exchange: constructed with nine million bricks.

Starting at **Amsterdam Centraal Station**, obtain a map from the VVV (Tourist Office) on Stationsplein and walk up Damrak, making sure that you don't get taken in by the obvious tourist traps along the way. You can't fail to notice the **Berlage's Exchange** (1903), most notable for its monumental qualities and use of nine million bricks.

Stone does not greatly feature here, but the sculpted lintels and quoins introduce Obernkirchener sandstone, one of a few good-quality materials that were imported in great quantities from West Germany – a source of stone that Holland still heavily relies upon for restoration work today.

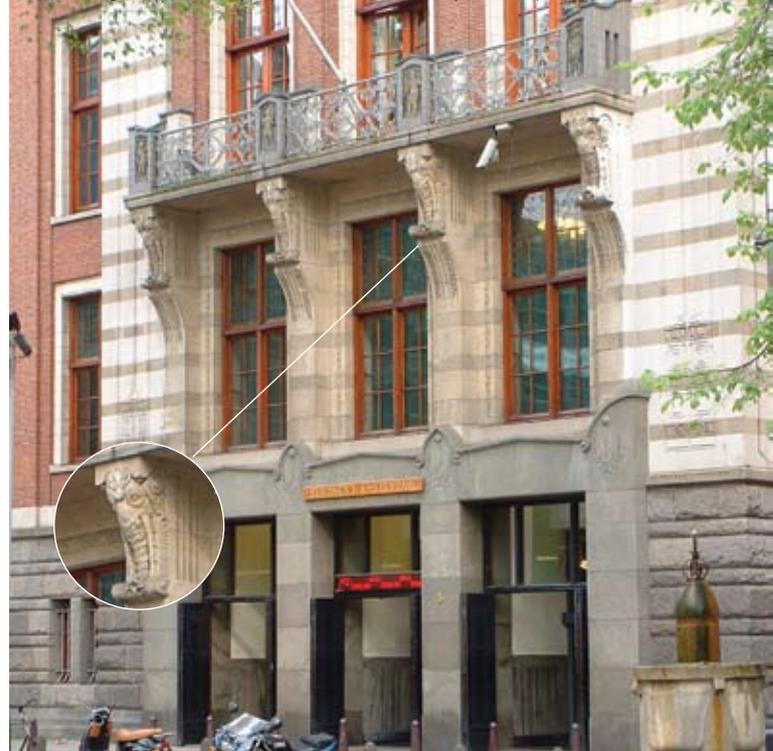
Stock Exchange: the carved elephants illustrate the durability of French Jurassic limestones.

At Beursplein, we encounter the old **Stock Exchange** (1916), now Euronext. Have a good look at the alternating bands of green/brown volcanic tuff from the Eifel region of Germany, and the contrasting pale cream French limestone. Here, the intricately carved elephant heads still retain their sharp lines – a good indication of the durability of the best French Jurassic limestones. At the rear of the building, there are some interesting frieze sculptures on Warmoesstraat.

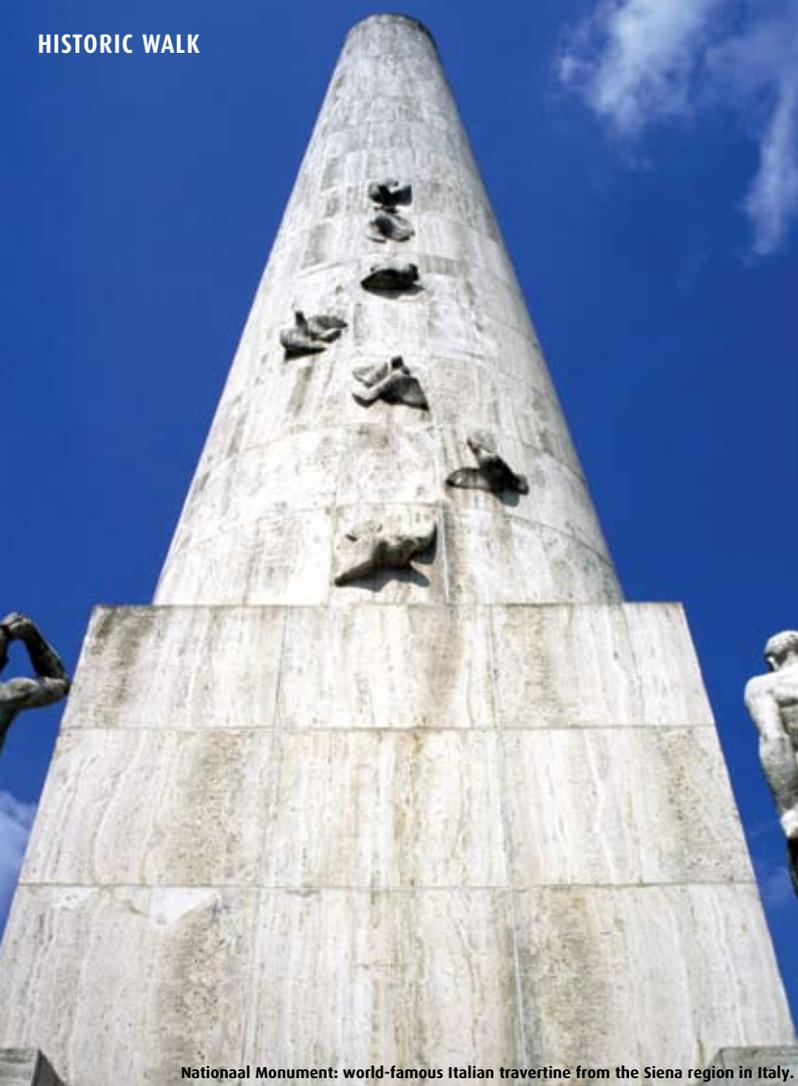
Nationaal Monument: world-famous Italian travertine from the Siena region in Italy.

At the **Nationaal Monument** (1956), we see an example of the world-famous Italian travertine from the Siena region in Italy. A similar material was used to build the Colosseum and much of ancient Rome. The Nationaal Monument has had conservation problems. A close look reveals damage associated with differential expansion between the cladding panels and the concrete and brick core. The monument has been dismantled and reconstructed to rectify these structural defects, and to combat indiscriminate attacks from vandals with aerosol sprays. It is now cleaned and washed on a regular basis.

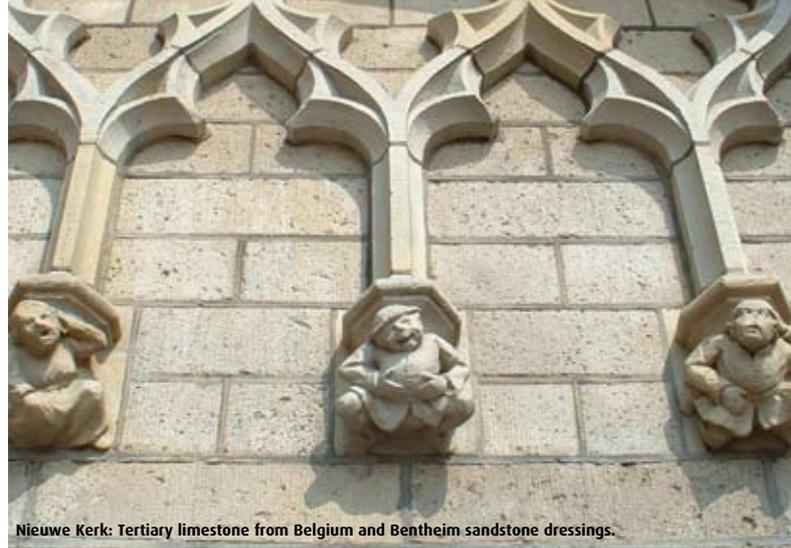
Nieuwe Kerk: Tertiary limestone from Belgium and Bentheim sandstone dressings.

At **Nieuwe Kerk** (1400-) we see another yellowish-coloured limestone, high up in the south elevation. This is a soft Tertiary limestone from Belgium. It was quarried from thin natural beds, with individual blocks of stone not much larger than a brick, and is suitable only for basic walling. Along with the similar Gobertange stone, it was frequently used in the Middle Ages but quickly superseded around 1500, when large blocks of the durable Bentheim sandstone, used here for dressings, became available in large quantities.

The south entrance porch and adjoining masonry provide a good opportunity to compare and contrast Bentheim sandstone and another example of Eifel volcanic tuff. From a distance, both possess a similar colour – grey/brown with yellowish variations – but, at close range, the tuff can be seen to be open-textured and poorly cemented; a factor that leaves this material highly susceptible to weathering.

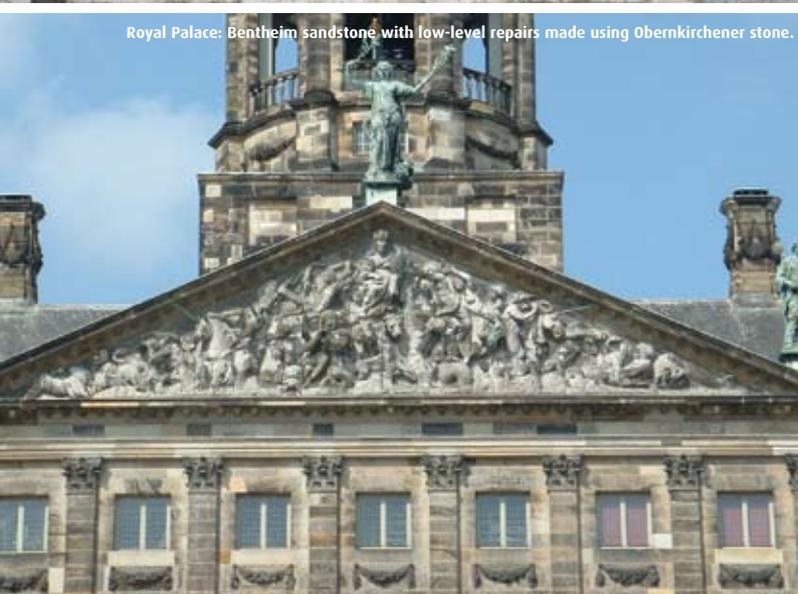
Royal Palace: Bentheim sandstone with low-level repairs made using Obernkirchener stone.

Cross to Dam Square and take a good look at the **Royal Palace** (1655), built as the New Town Hall by Jacob van Campen and using yet another German sandstone, Bentheim. Obernkirchener stone has been used for low-level repairs.

All three German sandstones visible from this point possess broadly similar characteristics: grey/light brown with varying degrees of natural iron content. With the cleaning of stone being currently out of favour in the Netherlands, the problems of matching colour aren't as acute as in the UK, but the stone restorer must pay attention to the grain size and inherent porosity of the stone. A poor specification in a climate that is frequently exposed to wind, rain and frost can lead to accelerated decay, especially on saturated weathering courses.

Before leaving the Royal Palace, take a good look at the frieze sculpture to the pediment and consider the problems of conserving such fine architectural work. The Italian Carrara marble from which it is carved is unsuited for external use in a cold, damp, northern European climate and will be subject to rapid decay, especially where acidic pollutants form such a blackened, gypsum-bearing crust.

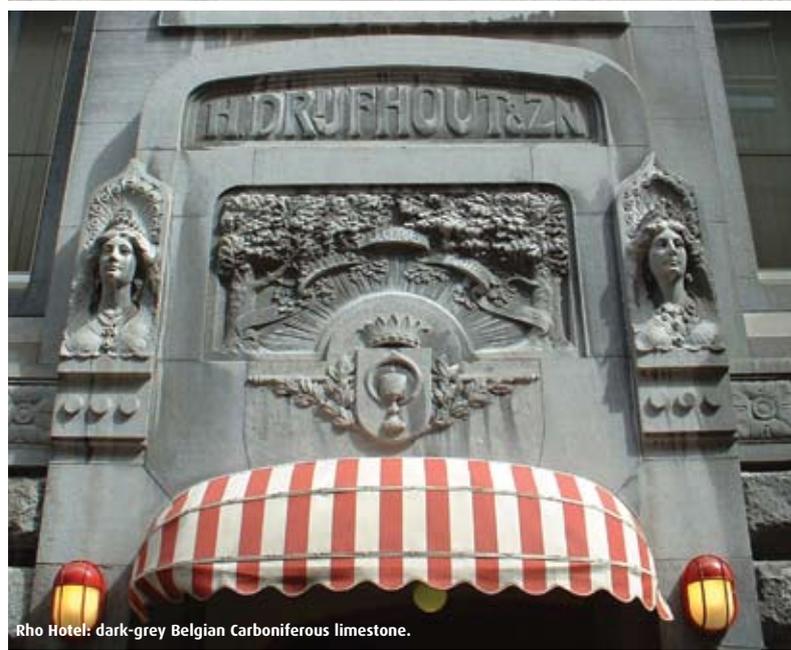
Rho Hotel: dark-grey Belgian Carboniferous limestone.

The next step is to wander down Nes, where the **Rho Hotel** (1908) provides an excellent example of dark-grey Belgian Carboniferous limestone.

Widely used throughout the Netherlands for its hard-wearing qualities, and mainly seen in paving and steps, its versatility is illustrated here in a wide variety of intricately tooled finishes. The richly-decorated stonework reflects the prosperity of its former owner, H Drijfhout & Zn, an Amsterdam gold trading company.

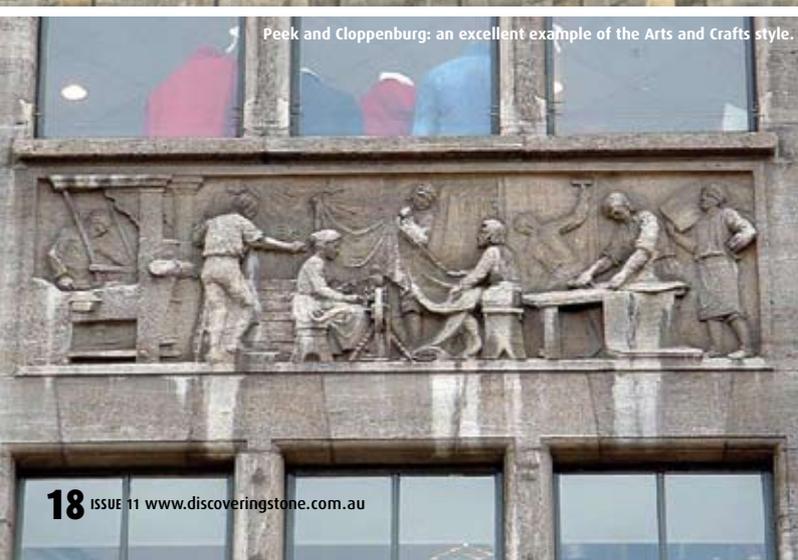
Peek and Cloppenburg: an excellent example of the Arts and Crafts style.

Cross Dam Square to the **Peek and Cloppenburg** (1916) building for yet another example of German stone, this time the Triassic Muschelkalk limestone. Although probably best suited for use as ashlar blocks, the frieze sculpture is an excellent example of the Arts and Crafts style.

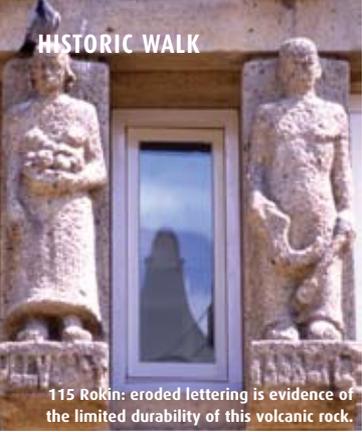
115 Rokin: eroded lettering is evidence of the limited durability of this volcanic rock.

The first leg of this walk around the Binnenstad of Amsterdam ends at **115 Rokin**, where the same geologically recent, compacted volcanic ash from the Eifel region in Germany that appeared in both the Stock Exchange and Nieuwe Kerk, is displayed. A coarse variety has been used for the sculpture and finer-grained stones for the weathering courses. The eroded lettering at the base of the statues is now barely legible, providing evidence of the limited durability of this volcanic rock.

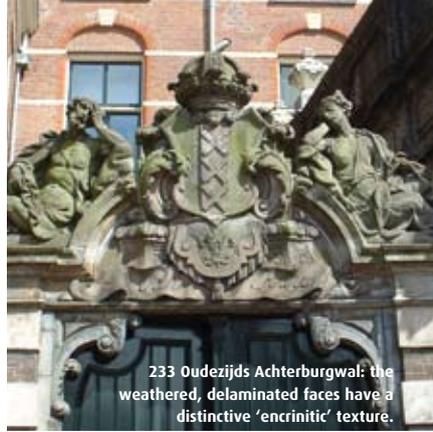
233 Oudezijds Achterburgwal: the weathered, delaminated faces have a distinctive 'encrinitic' texture.

sculpture carved in Bentheim sandstone. Take a good look at the pale limestone blocks that form the pilasters. This Jurassic limestone is from Euville in France. Although, at a distance, the colour and texture appears very similar to other Jurassic oolitic and shelly limestones, a close inspection of the weathered, delaminated faces will reveal a distinctive 'encrinitic' texture comprising sparkling, crystalline fragments of fossil crinoids or 'sea lilies'.

Compare this stone with the dark grey Belgian Carboniferous limestone that is used for the decorative jambs and the plinth.

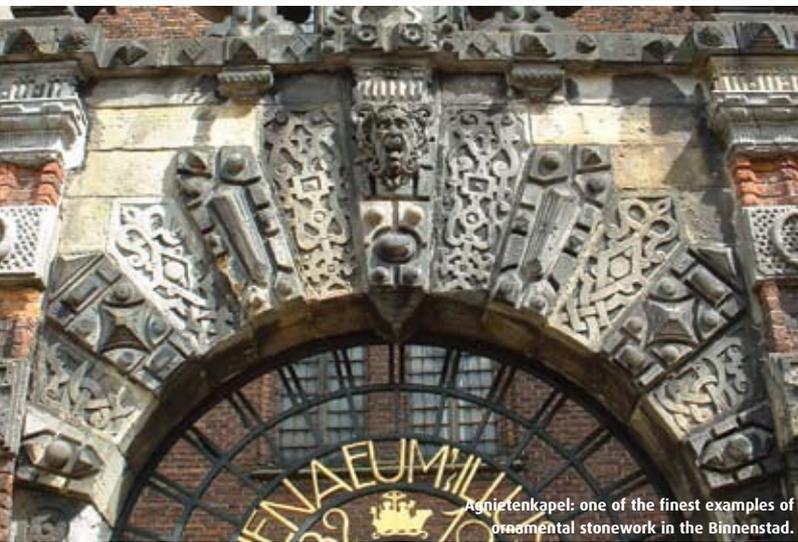
Agnietenkapel: one of the finest examples of ornamental stonework in the Binnenstad.

Continue along Oudezijds Voorburgwal to the gateway of the **Agnietenkapel** (1571), where there is one of the finest examples of ornamental stonework in the Binnenstad. Here, the ubiquitous Bentheim sandstone is seen to be weathered black, typical of all kinds of sandstone, and contrasts with the very pale Belgian Carboniferous limestone, with its distinctive laminations, used for the boldly carved pilaster blocks.

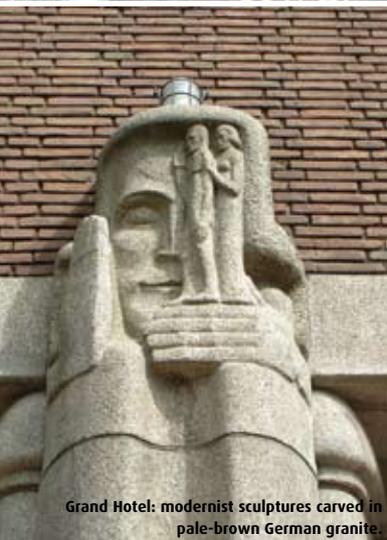
Grand Hotel: modernist sculptures carved in pale-brown German granite.

The austere brick extension to the former Town Hall (1924) conceals one of the city's architectural treasures, the old Admiralty, built in Classical Baroque style. Now part of the luxurious **Grand Hotel**, the façade is especially notable for the fine sculptures by Hildo Krop carved in pale brown German granite. Many of his other distinctive modernist sculptures, using similar material, decorate many of the large bridges and other fine monuments in central Amsterdam.

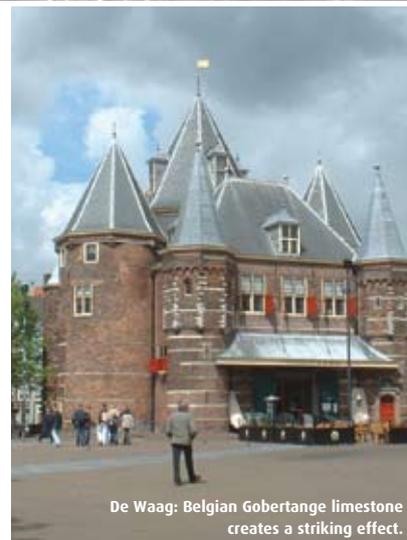
De Waag: Belgian Gobertange limestone creates a striking effect.

Crossing back over the canal and cutting through to the southern end of Nieuwmarkt, you will be presented with the best view of the magnificent **De Waag** (1488), formerly an ancient entrance to the city and once known as St Anthony's Gate. It is the brickwork and the magnificent roof that first catches your eye but here the Belgian Gobertange limestone has been used for a striking decorative effect.

At close quarters, examine the stone string courses and quoins, and note how the limestone has weathered poorly in comparison with the brickwork and the Bentheim sandstone that has been used for the corbelled base of the octagonal section of the turrets. Many of the original limestone quoins have since been replaced with the more durable sandstone. At lower level, fine relief carvings to the lintels above the doorways depict the tools and symbols of the respective trade guilds housed in each turret.

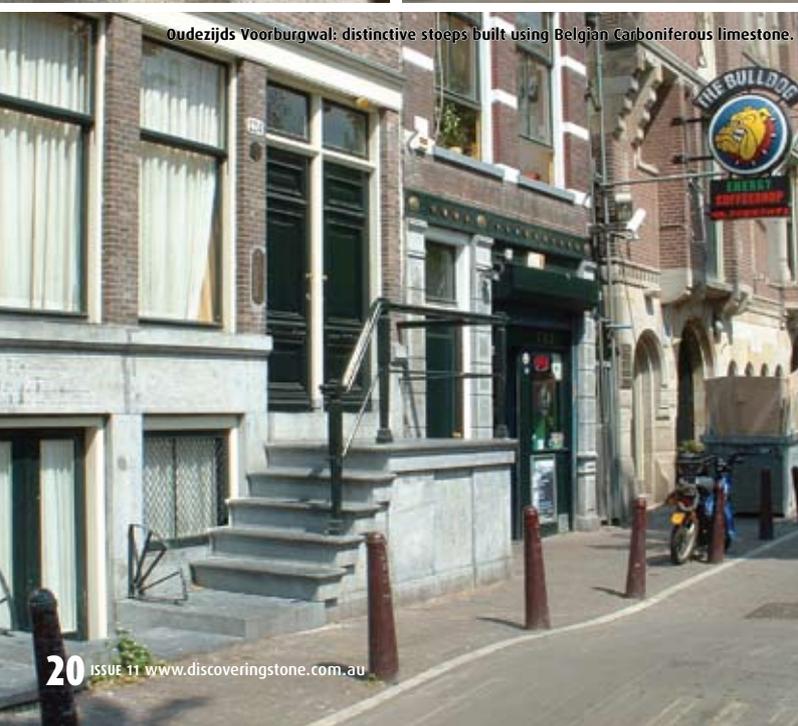
Oudezijds Voorburgwal: distinctive stoeps built using Belgian Carboniferous limestone.

At this point, take some time to examine the typically Dutch townhouses of **Oudezijds Voorburgwal**, where the ground floors and the distinctive steps are predominantly built using Belgian Carboniferous limestone. Unfortunately, despite its World Heritage status, there is neglect of some of the buildings and graffiti problems persist. A typical use of this limestone can be seen at 224, where a variety of tooled finishes, including lettering, are displayed.

At other locations, on weathered surfaces, you may see crenulated laminations parallel to the natural bedding planes, called stylolites, which have opened up and are now considered to be a potential defect and to be avoided in stone for restoration work. While Belgium has been the historic source of these limestones, Rijksdienst voor De Monumentenzorg, the state conservation agency, have investigated

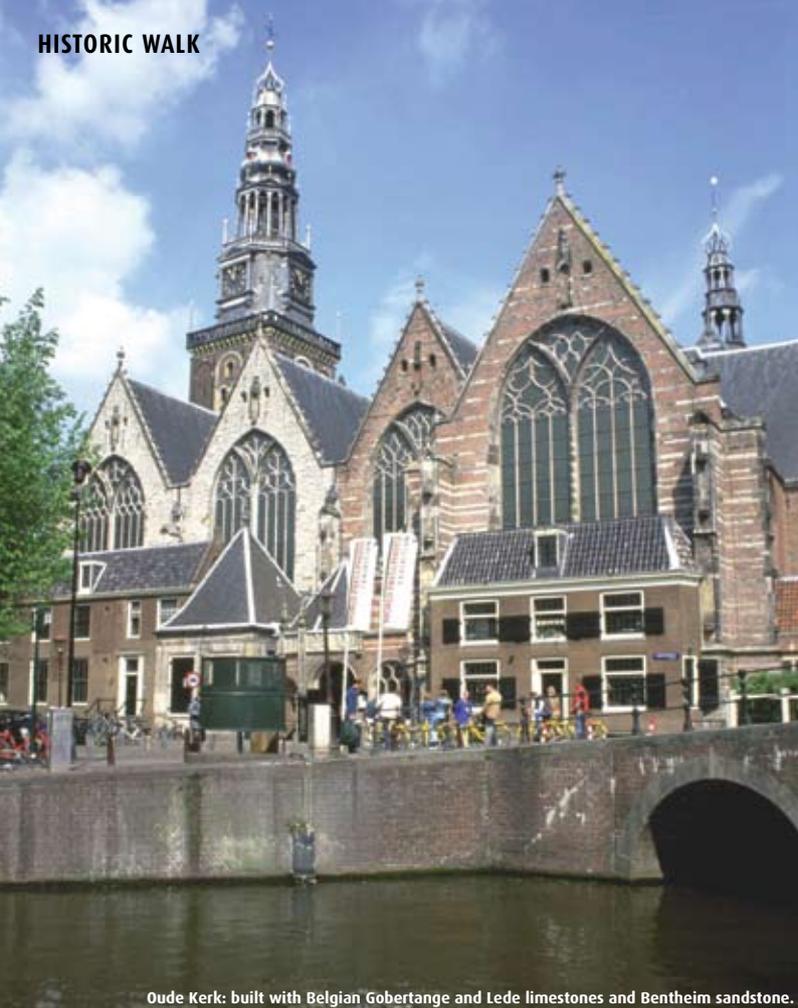
Oude Kerk: built with Belgian Gobertange and Lede limestones and Bentheim sandstone.

From De Waag, walk down Molen Steeg and Oude Kennis Steeg and stop to take in the view of **Oude Kerk** (1300-). In common with most large ancient churches, Oude Kerk has been extended, partially rebuilt and extensively restored over the years, with a wide variety of materials. When unravelling the construction history of such buildings, archaeological investigation usually relies on existing documentation but a study of the building stone and structural details can often provide vital clues.

Here, the distinctive soft, thinly-bedded, cream-coloured Belgian Gobertange and Lede limestones were used between 1350-1400, with a sharp transition to the use of German Bentheim sandstone after 1450. Above the south entrance to Oude Kerk, we also see an elaborate Muschelkalk limestone relief carving on one of the later additions to the church.

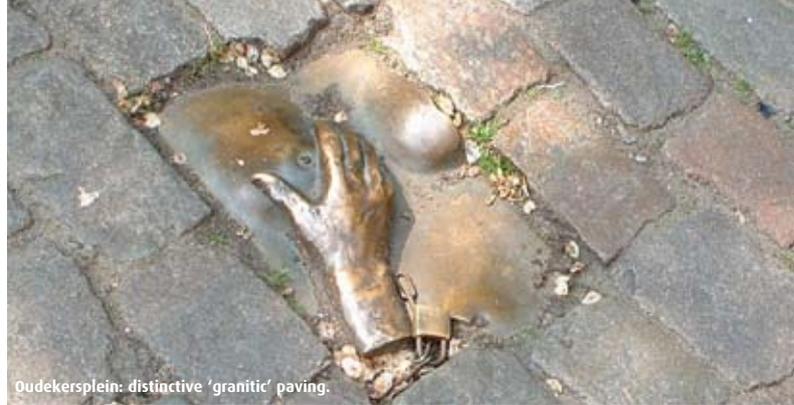
Oudekerksplein: distinctive 'granitic' paving.

Don't forget that the distinctive 'granitic' paving at **Oudekerksplein**, with its wide variety of colours and textures, also contributes significantly to the ancient urban landscape. All too often, repairs to historic pavements are undertaken with scant regard to the original provenance of the materials. Even a well-qualified geologist will struggle to find a suitable match for these old igneous rocks, whose original quarry sources include Belgium, Scandinavia, the Channel Islands and Scotland.
